PHASE I ENVIRONMENTAL SITE ASSESSMENT REPORT

STONE ACADEMY
745 Burnside Avenue
East Hartford, CT 06108

HRP# COL4100.P2

Issued On: February 25, 2026

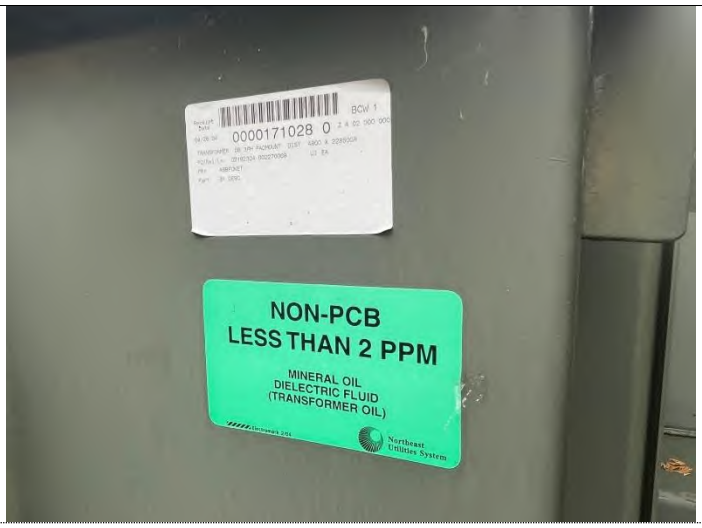
A pad-mounted electrical transformer was observed on the western side of Subject Property. The transformer had a sticker indicating that the transformer contained dielectric oil with less than two parts per million (2 ppm) of polychlorinated biphenyls (PCBs). No obvious staining was observed on and/or beneath the transformer. Due to the potential for a release, this location is considered an AOC.

Photo 8: Non-PCB sticker on the electrical transformer.
